# Safe Drinking Water in Mariveles, Philippines

Our first Philippine community system, at a local church in Mariveles, Bataan, passed its bacteria test and serves 100 to 200 people a day. This report covers the design, results, running costs and the next system for an indigenous Aeta school.

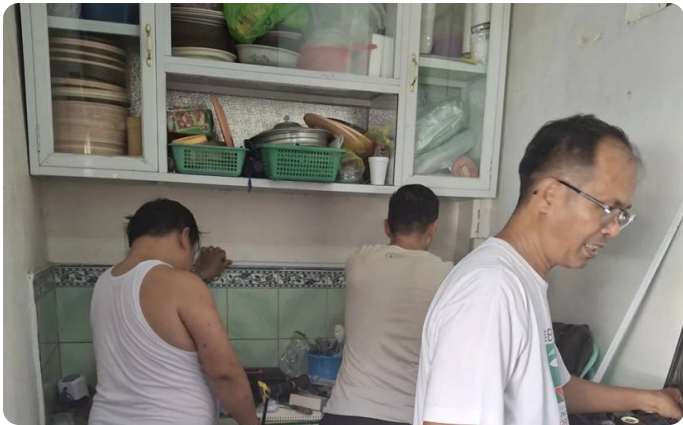
Installing the system

We measured the church’s water line in August 2025 and designed a compact system that fits in a cabinet between two rooms, with a tap through the wall to the street. Equipment was bought in March 2026 and installed with local volunteers.

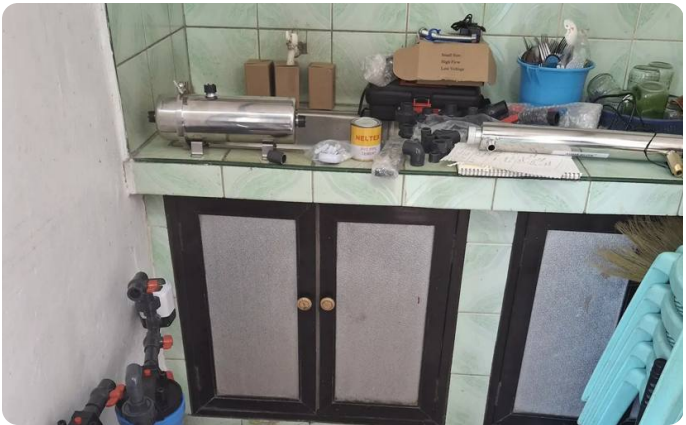
The finished system

System one design
